TECHNICAL REPORT ABOUT A "ZERO DRAIN" CLEANING AND PROTECTION OF HEATING SYSTEM according to standard UNI 8065 (D.P.R. 74/13)

System managing company: **A2A CALORE E SERVIZI**

System interested by our intervention: **School complex – Via F.lli Calvi n. 8 – Bergamo (BG)**

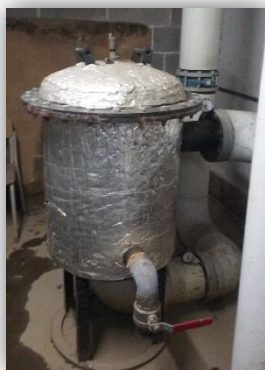
Picture 1

- Water circulating treatments:
In line filtration named "magnetic filter" (picture 1)

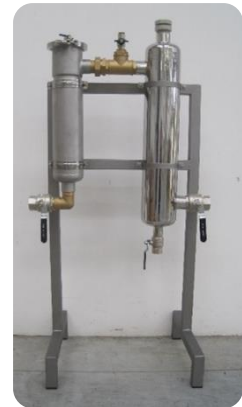
- Filter type installed: MAG CLEANER 120
- Connections DN 40 (1" ½)
- Accessories mounted in the filter outlet: flowmeter and circulating pump
- MAG CLEANER system flow rate: min. 4 m³ max. 10 m³

TEMPORARY INSTALLATION of the filtering system MAG CLEANER (2 – 3 months)

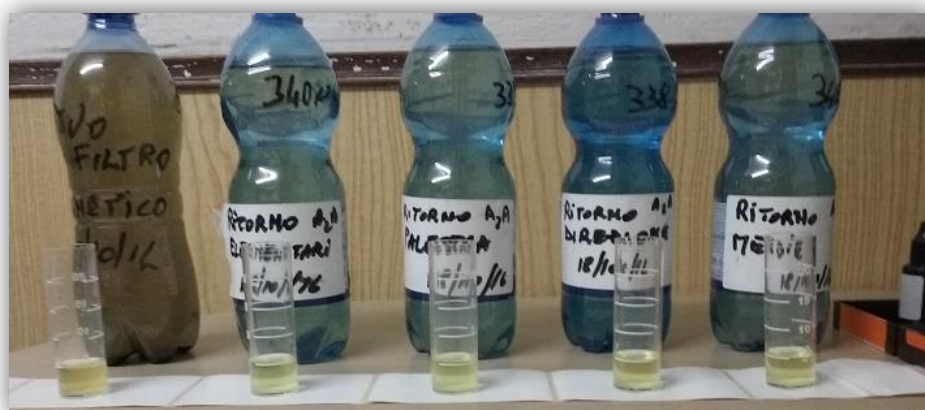
After eight days it has been effected the first system check and the first magnetic filter cleaning. From the water check, it has resulted a low concentration of the chemicals (Picture 2).

Picture 2 – Inhibitor concentration rate in all the samples taken in the different system areas.

4th and 18th November 2016: it has been checked the products concentration on site, and according to the results, it has been considered to introduce an additional products quantity.

18th November 2016: it has been introduced another quantity of PROTECT 1 and CLEAN 1 products, bringing their concentration rate to 0,5% of the system water volume. Consequently, it has been proved the correct system water volume: 8.000-9.000 litres.

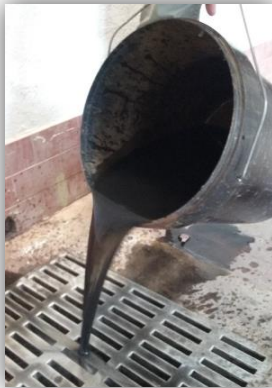
Magnetic filter draining

During both the checks it has been cleaned the magnetic filter, replaced the filtering bag and checked the constancy of MAG CLEANER recirculation flow rate.

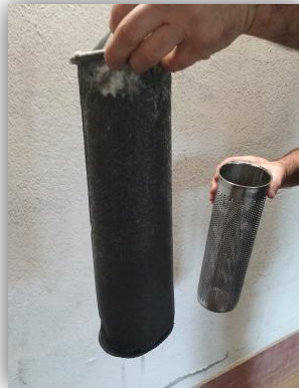
Filtering sock removal and substitution

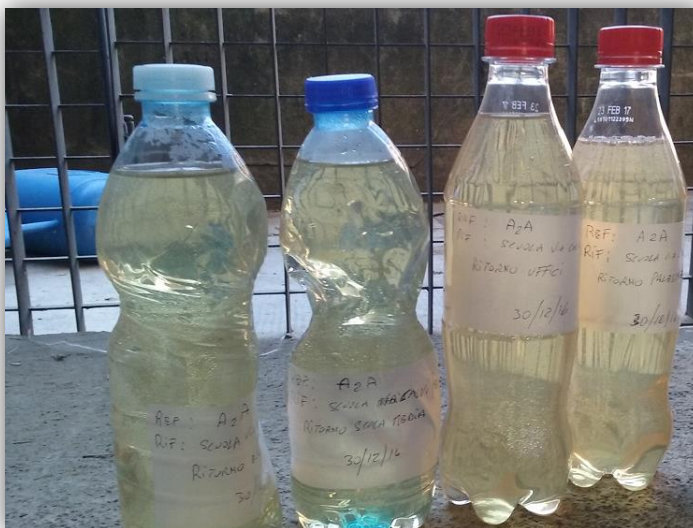
Picture 3

26th January 2016: it has been experienced a stabilized situation, where the water has resulted always clear, slightly yellowish (this is a typical colour given by the presence of the inhibitor PROTECT 1), without any sediment in the various water return circuit (see picture 3.). Consequently, the operation could be considered finished.

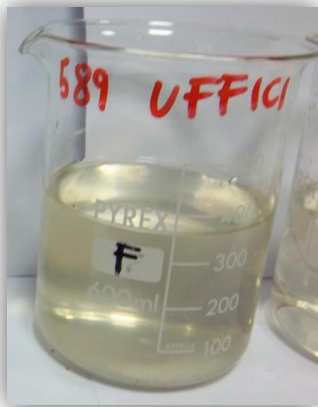
Picture 4

The excellent result achieved has been highlighted by the water sample taken from the system return, which has represented the initial and more compromised situation (picture 2). Now, as it can be seen from picture no. 4, the water has turned out clear and free from any sediment.

From this stage onwards, our MAG CLEANER magnetic filter system can be disconnected.

It is suggested to install a permanent magnetic filter as our T-MAG XL in order to collect and remove any magnetic particles that may be formed.

It is also suggested to maintain a sufficient amount of our inhibitor PROTECT 1 into the system. Periodically, the product concentration rate has to be checked by KIT PROTECT 1 test device on site, in order to guarantee the absence of any corrosive phenomena caused by water circulation and maintain the maximum energy efficiency.
